Manhole Inspection Summary

Manhole # S23I__003MH

Location Address: **1400 W Lombard St**

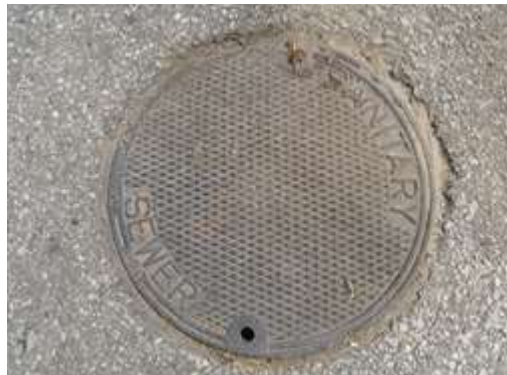
Cover View

Condition: **Sound**

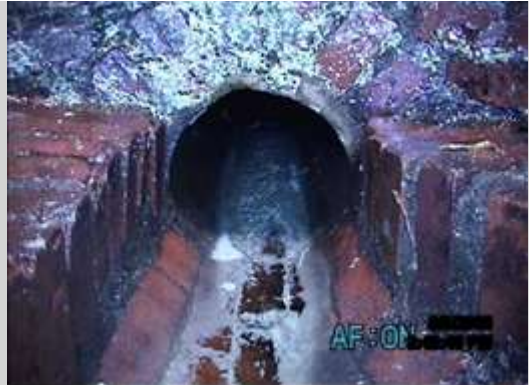
12 O'Clock Outflow

Pipe Height: **8.4** (in.) Rod and Bar (Angled)
Pipe Material: **Clay** ☐ Pipe Lined
Invert Depth: **12.19** (ft.) Flow Characteristics: **Slow**
Deposits: ☒ None ☐ Mud ☐ Sludge ☐ Debris ☐ Grease
Silt Depth: **0** (in.) Deposits Extent:
Infiltration: **None** Pipe Seal Cond: **Sound**

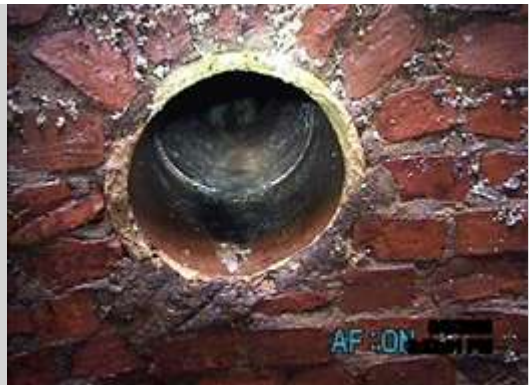
3 O'Clock Inflow

Pipe Height: **8.4** (in.) Rod and Bar (Angled)
Pipe Material: **Clay** ☐ Pipe Lined
Invert Depth: **10.12** (ft.) Flow Characteristics: **None**
Deposits: ☒ None ☐ Mud ☐ Sludge ☐ Debris ☐ Grease
Silt Depth: **0** (in.) Deposits Extent:
Infiltration: **None** Pipe Seal Cond: **Sound**

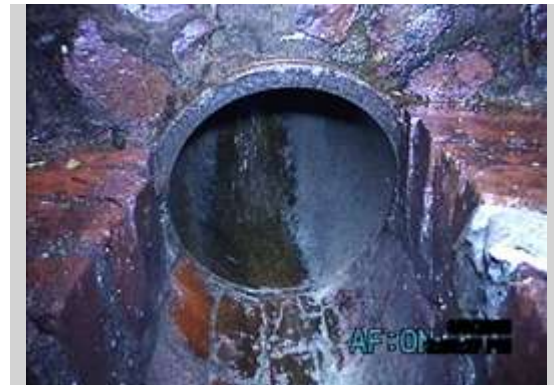
Drop In @ 3 O'Clock

Drop: **Outside** Rod and Bar
Angled: **Yes** Reading: **10.87** (ft.)
Inv Depth: **11.87** (ft.)

Drop Condition: **Open**

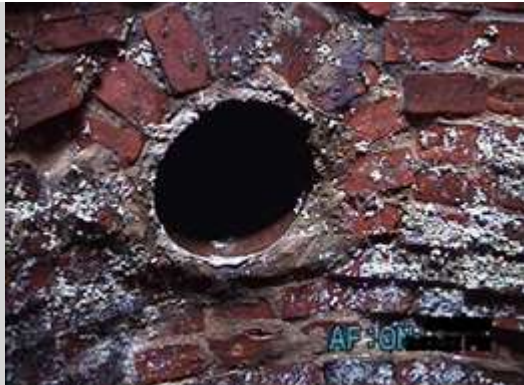
6 O'Clock Inflow

Pipe Height: **8.4** (in.) Rod and Bar (Angled)

Infiltration: **None** Pipe Seal Cond: **Sound**

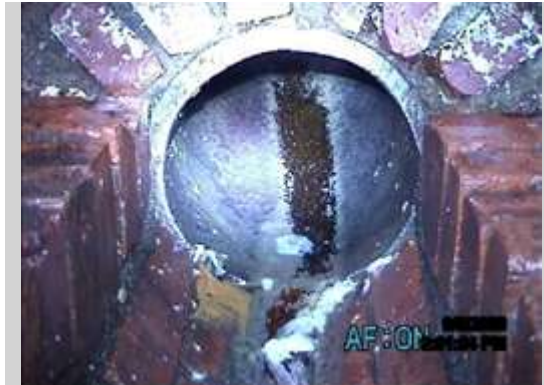
Drop In @ 6 O'Clock

Drop Condition: **Open**
